# Strukton Immersion Projects

Underwater habitat at atmospheric pressure

**Chioggia CBA02-Habitat - Italy**

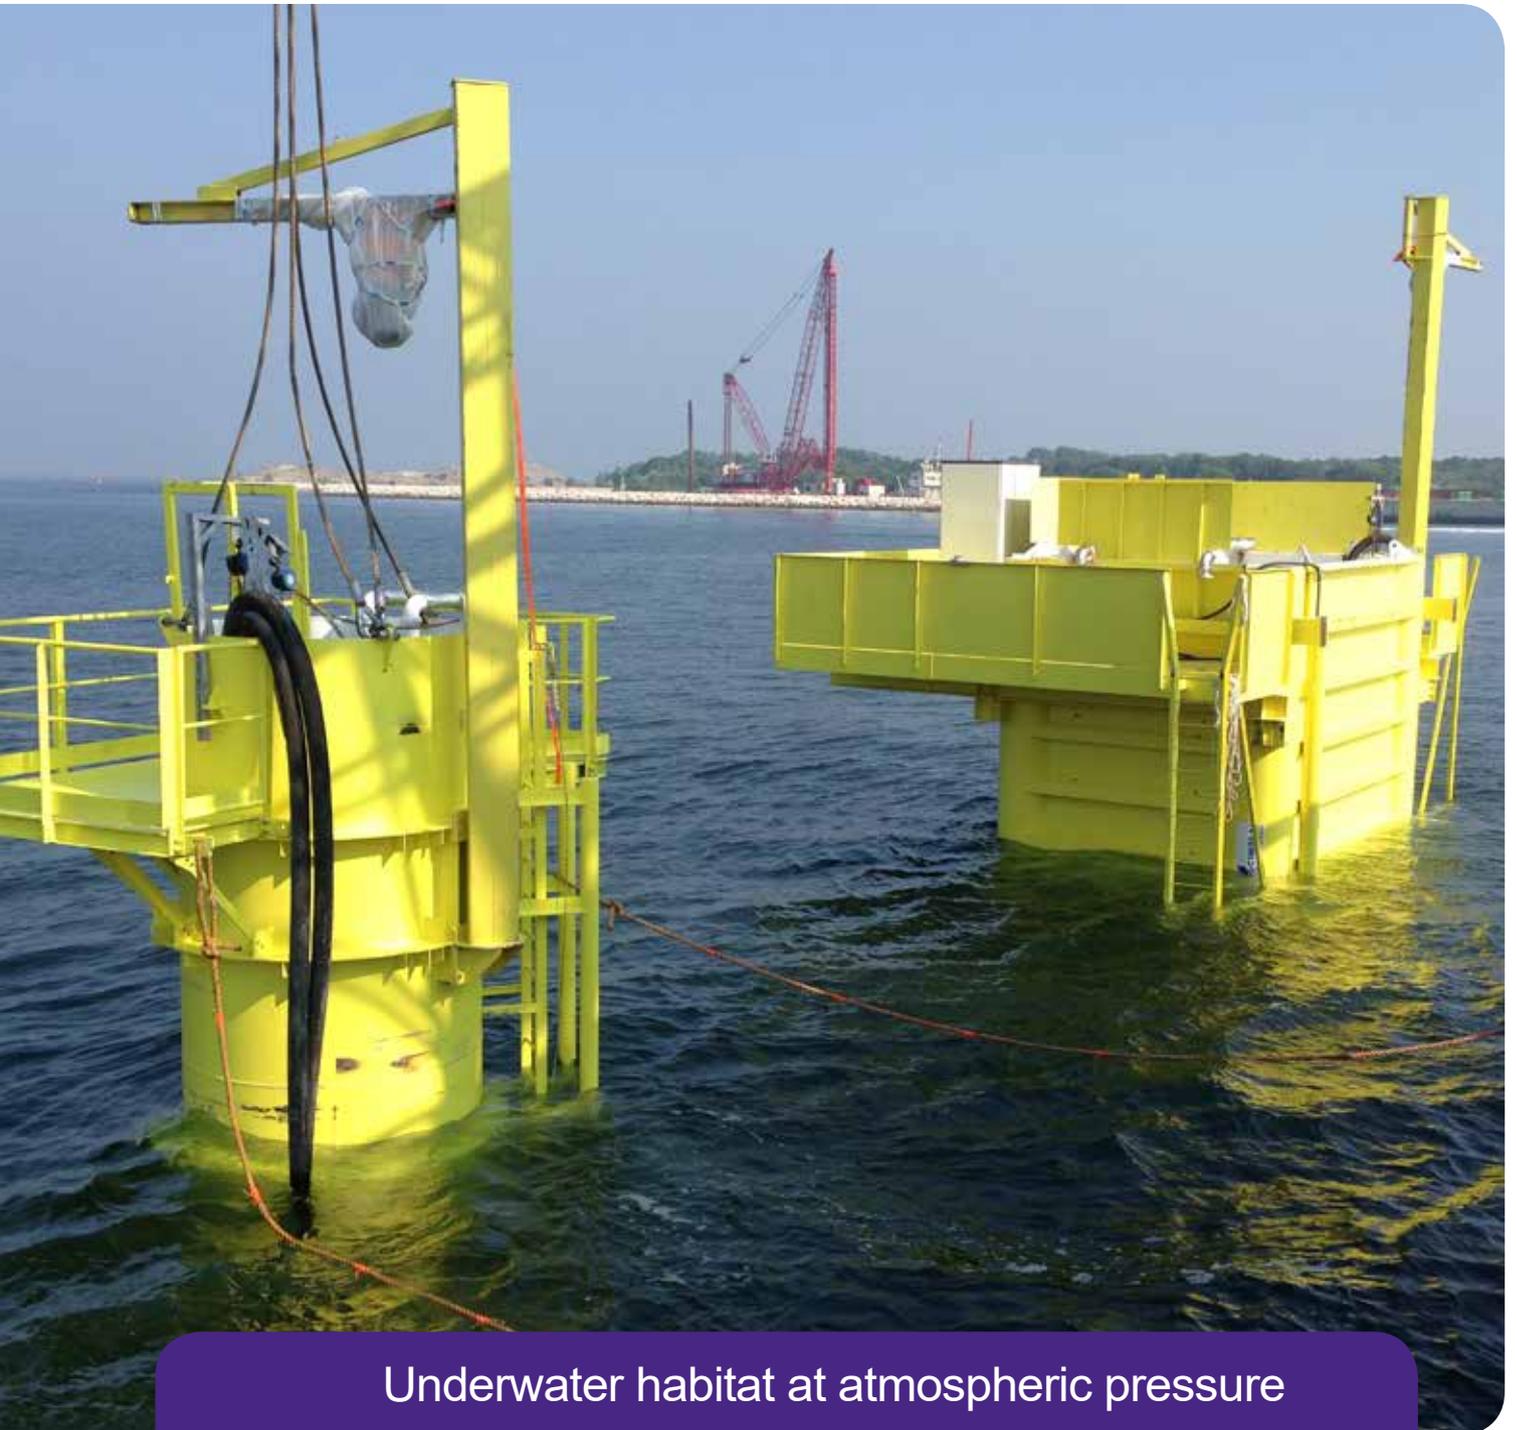
Design, engineering and installation of an “underwater habitat at atmospheric pressure” (watertight space) for demolition / recovery works of a caisson roof of the Chioggia Flood Barrier.

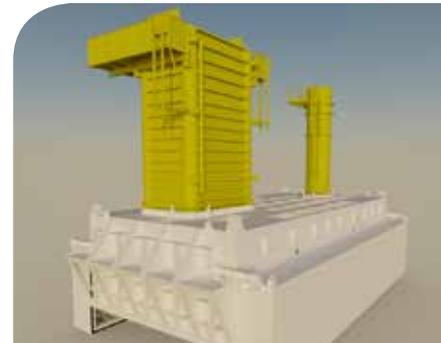
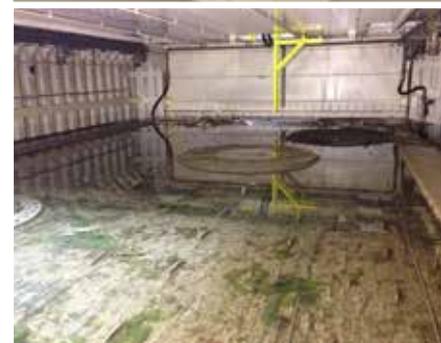
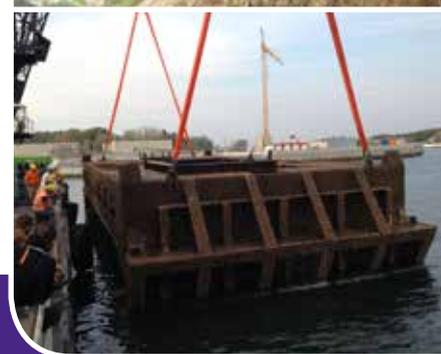
In six months' time a steel habitat was designed and constructed to be able to execute the required dry inspection, demolition and repair works. Design, preparations and installation of the habitat were within the scope of work of Strukton, where construction of the habitat and demolition/repair of the caisson roof were in the scope of the client. The habitat consisted of three parts (one middle section and two side boxes) and two access shafts. All parts were connected with specialized rubber seals.

The weight of the total structure was about 400 ton and it was produced in a steel fabrication plant in Italy. After transport over water on a barge, all the parts were lifted and accurately positioned piece by piece with two floating cranes under water with diving assistance of OTN.
